Hotel Fitness Amenity Review Report

Formal CAD review report generated from structured demo data

Project Name	Sample hotel Fitness Amenity Review
Property Information	Sample hotel · Upscale · 120 Rooms
Source File	Prepared CAD floor plan
Review Scope	Fitness Center / Changing Room / Pool
PDF Pages	1

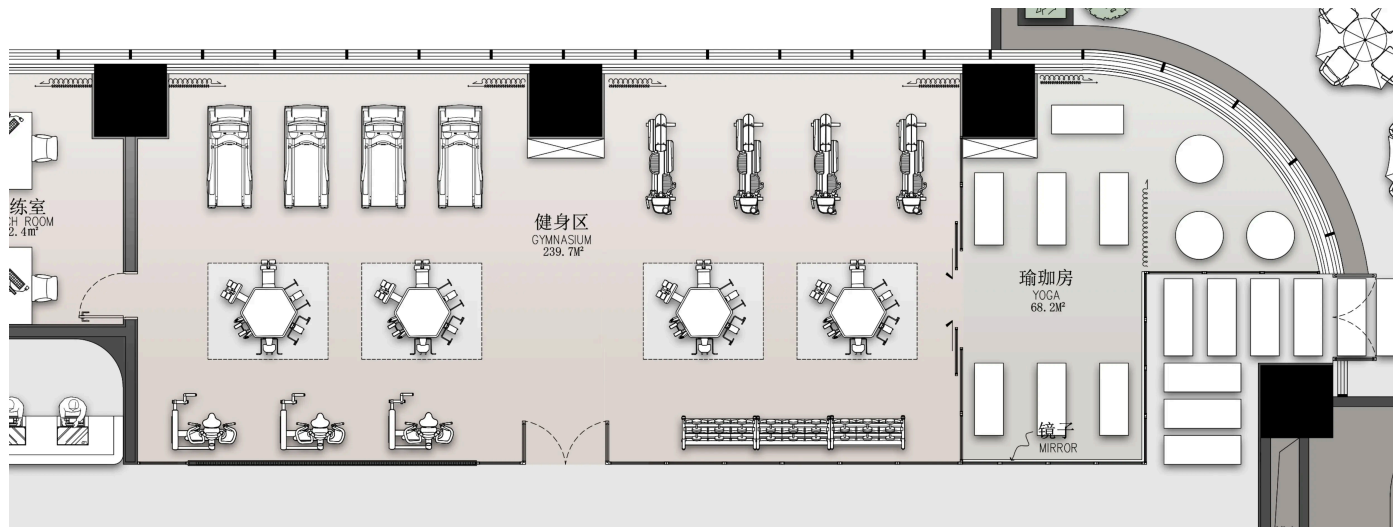
Figure 1: Fitness Center / Page 1

No.	Rule	Status	Review Finding	Drawing Reference
1	Fitness Center Provided	✓ Compliant	Complies. The plan includes a dedicated fitness center with a clearly defined room boundary and fitness equipment layout.	page 1
2	Fitness Center Minimum Area	✓ Compliant	Complies. The fitness center is noted at 239.7 sq m, exceeding the 100 sq m requirement for this chain-scale profile.	page 1
3	Treadmill Rear Clearance	! Need Human Review	Requires reviewer confirmation. Treadmills are shown, but rear clearance dimensions are not annotated clearly enough to verify the 1.8 m minimum.	page 1
4	Equipment Clear Floor Area and Spacing	! Need Human Review	Requires reviewer confirmation. The equipment layout is visible, but clear floor areas and equipment-to-equipment spacing are not dimensioned.	page 1
5	Treadmill Quantity	✓ Compliant	Complies. Four treadmills are shown, exceeding the minimum quantity of two.	page 1

6	Elliptical Trainer Quantity	✓ Compliant	Complies. Three elliptical trainers are shown, exceeding the minimum quantity of two.	page 1
7	Recumbent Bike Quantity	⊘ Non-compliant	Does not comply. No recumbent bike is identifiable in the submitted fitness center layout.	page 1
8	Functional Trainer Quantity	✓ Compliant	Complies. The plan shows multiple multi-station strength units, meeting the functional trainer requirement.	page 1
9	Dumbbell Rack Quantity	✓ Compliant	Complies. One dumbbell rack is shown, satisfying the minimum requirement.	page 1
10	General Storage Rack Quantity	⊘ Non-compliant	Does not comply. A general storage rack is not shown in the fitness center.	page 1
11	Adjustable Bench Quantity	⊘ Non-compliant	Does not comply. The required adjustable benches are not identifiable in the plan.	page 1
12	Chest Press Machine Quantity	! Need Human Review	Requires reviewer confirmation. Strength machines are shown, but their specific machine types are not labeled.	page 1

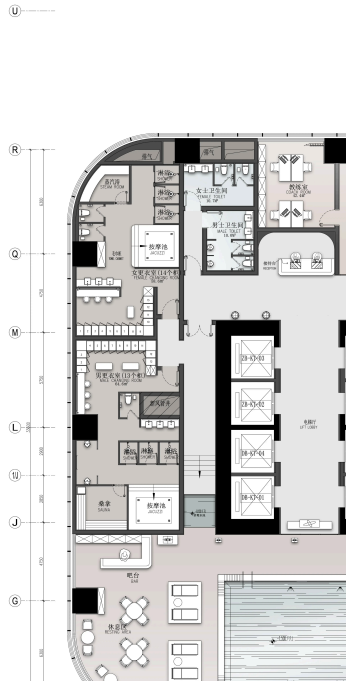
Figure 2: Changing Room / Page 1

No.	Rule	Status	Review Finding	Drawing Reference
1	Male and Female Changing Rooms Provided	✓ Compliant	Complies. Separate male and female changing rooms are shown in the amenity plan.	page 1
2	Changing Suite Aggregate Area	! Need Human Review	Requires reviewer confirmation. Labeled changing and toilet areas total 143.9 sq m, while several support spaces lack area annotations needed to verify the 280 sq m target.	page 1
3	Male and Female Separation	✓ Compliant	Complies. Male and female changing rooms are physically separated.	page 1
4	Direct Access from Reception	✓ Compliant	Complies. The changing rooms are adjacent to the reception circulation path and have direct access from the amenity corridor.	page 1
5	Wet and Dry Zone Separation	✓ Compliant	Complies. The layout separates lockers and grooming functions from wet amenities and toilets.	page 1
6	Dry-Zone Amenity Set	⚠ Non-compliant	Does not comply. Locker and changing areas are present, but enclosed private changing rooms are not shown.	page 1

7	Wet-Zone Amenity Set	✓ Compliant	Complies. The wet-zone amenity set is represented in the changing suite.	page 1
8	Changing Room Seating	✓ Compliant	Complies. Seating is provided in both male and female changing rooms.	page 1
9	Private Dressing Rooms	⚠ Non-compliant	Does not comply. Private dressing rooms are not shown in either changing room.	page 1
10	Dressing Table Seating	⚠ Non-compliant	Does not comply. Dressing counters are visible, but stools or seats at those counters are not shown.	page 1
11	Locker Count by Room Count	⚠ Non-compliant	Does not comply. The plan provides 13 male lockers and 14 female lockers, below the calculated requirement of 18 lockers per side.	page 1
12	Shower Count by Room Count	✓ Compliant	Complies. Shower counts meet the calculated minimum for each gender suite.	page 1
13	Toilet Area by Gender	✓ Compliant	Complies. Both gender-specific toilet areas meet the 10 sq m minimum.	page 1

14	Toilet Compartment Dimensions	! Need Human Review	Requires reviewer confirmation. Toilet compartments are shown, but compartment width and depth are not dimensioned.	page 1
15	Toilet Fixture Count by Locker Count	✓ Compliant	Complies. The visible toilet fixture counts satisfy the minimum ratios derived from the locker counts.	page 1
16	Sauna Room Area	! Need Human Review	Requires reviewer confirmation. A sauna room is shown, but its area is not labeled.	page 1
17	Steam Room Area	! Need Human Review	Requires reviewer confirmation. A steam room is shown, but its area is not labeled.	page 1
18	Jacuzzi Area and Depth	! Need Human Review	Requires reviewer confirmation. Jacuzzi basins are shown, but area and water-depth annotations are not provided.	page 1

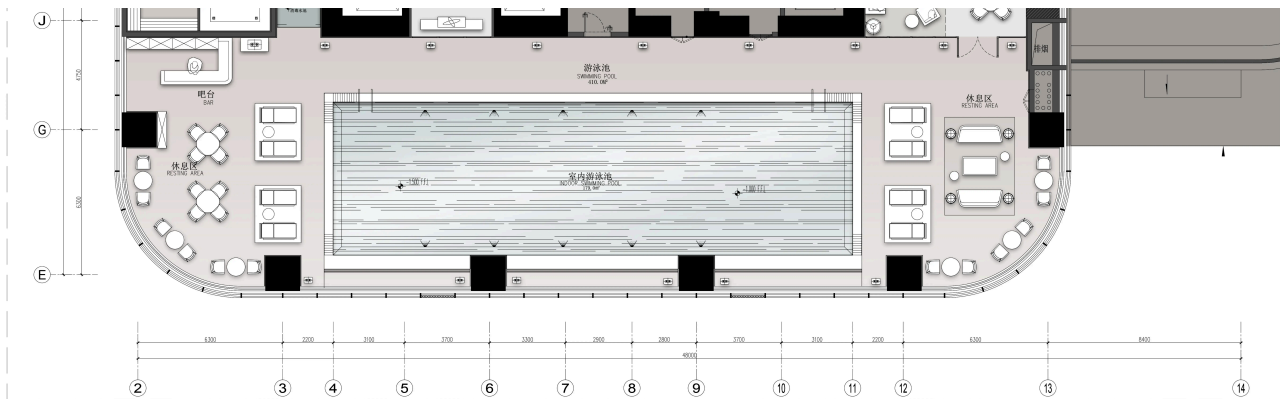
Figure 3: Pool / Page 1

No.	Rule	Status	Review Finding	Drawing Reference
1	Swimming Pool Provided	✓ Compliant	Complies. The plan includes a dedicated indoor swimming pool area.	page 1
2	Pool Area Total	✓ Compliant	Complies. The pool area is labeled 410.0 sq m, exceeding the 400 sq m target and the hard minimum.	page 1
3	Pool Water Surface Area	✓ Compliant	Complies. The indoor pool water surface is labeled 179.0 sq m, exceeding the 150 sq m minimum.	page 1
4	Pool Length Recommendation	✓ Compliant	Complies. The pool length is shown as 48.0 m, exceeding the 25 m recommended length.	page 1
5	Pool Bottom Slope Direction	✓ Compliant	Complies. The pool bottom transitions from a shallower end to a deeper end.	page 1
6	Connection to Changing and Lounge Areas	✓ Compliant	Complies. The pool area is directly connected to changing and lounge functions.	page 1
7	Foot-Dip Disinfection Pool Provided	✓ Compliant	Complies. A mandatory pass-through foot-dip disinfection pool is shown at the pool access route.	page 1

8	Pool Bottom Slope Range	✓ Compliant	Complies. The inferred bottom slope is approximately 2.84 percent, within the applicable range for the noted depths.	page 1
9	Pool Water Depth Limits	✓ Compliant	Complies. The indicated shallow and deep ends remain within the required water-depth limits.	page 1
10	Foot-Dip Disinfection Pool Length	! Need Human Review	Requires reviewer confirmation. The foot-dip pool is present, but its length is not dimensioned.	page 1
11	Pool Deck Circulation and Lounge Layout	! Need Human Review	Requires reviewer confirmation. The pool deck and lounge areas are shown, but clear circulation dimensions and lounge-chair spacing are not fully annotated.	page 1
12	Pool Suction Outlet Quantity and Spacing	! Need Human Review	Requires reviewer confirmation. Suction outlet quantity and spacing cannot be verified from the visible plan information.	page 1
